# SAFETY OF WIND SYSTEMS

© M. Ragheb  
2/26/2011

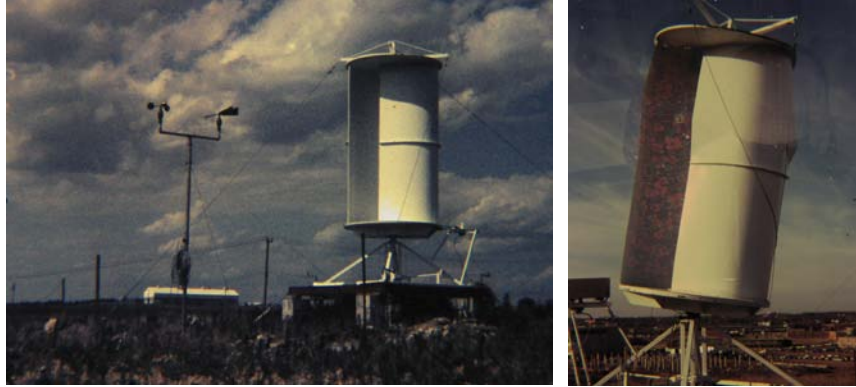
Figure 4. High winds damage effect on an experimental Savonius design wind turbine at Kansas State University, KSU.

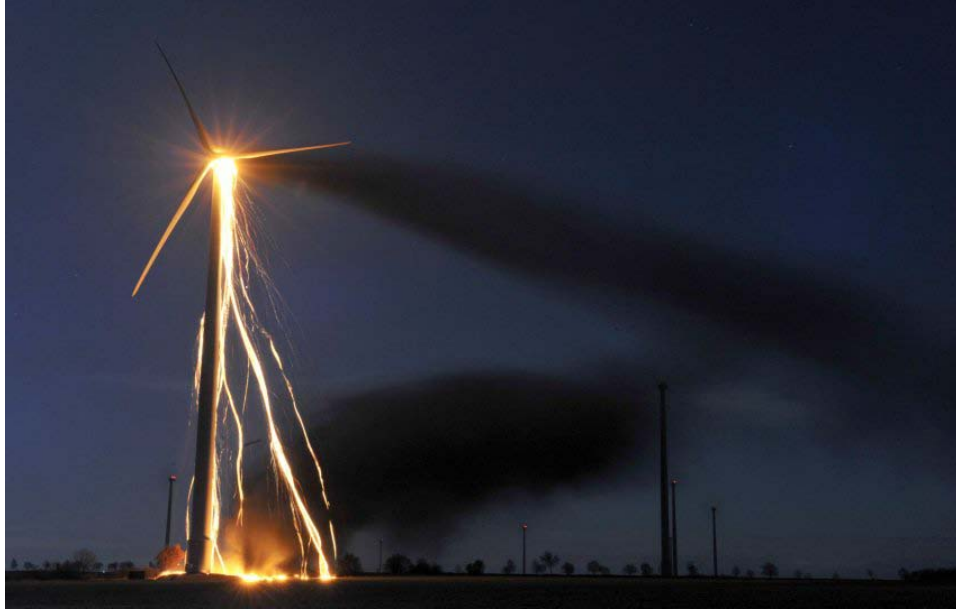
Figure 5. Wind turbine with ignited leaking lubrication oil near Uelzen, Lower Saxony, Germany, December 2, 2009. Source: DPA.

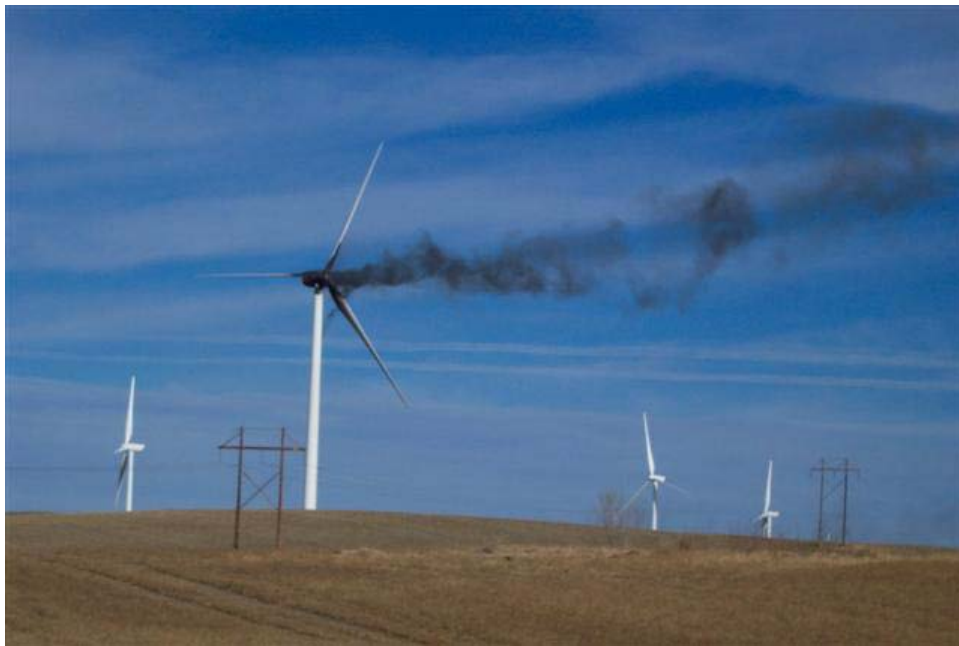
Figure 6. Wind turbine nacelle fire near Bloomingdale, Minnesota, USA, 2008.

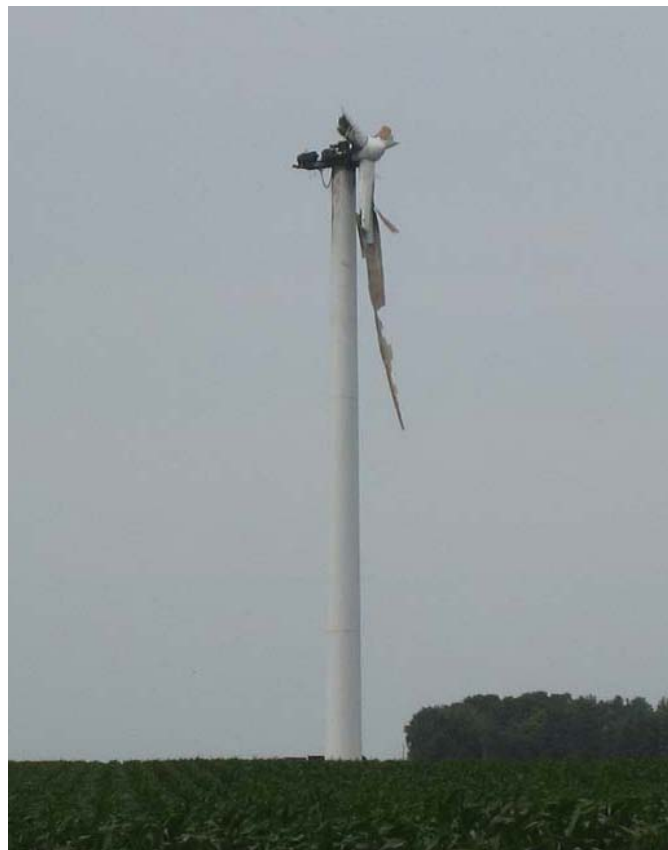
Figure 7. Lightning strike damage on a wind turbine in southern Minnesota, USA, resulted in the destruction of the nacelle and the rotor blades.

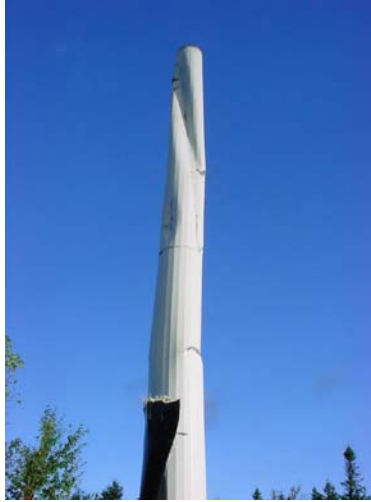
Turbine collapse occurred in high wind conditions at the Searsburg, Vermont wind facility on September 15, 2008. One of the rotor blades hit the base causing the tower to buckle and the nacelle and rotor assembly to crash to the ground.

Figure 9. Turbine collapse in high wind conditions at the Searsburg, Vermont wind facility, September 15, 2008.

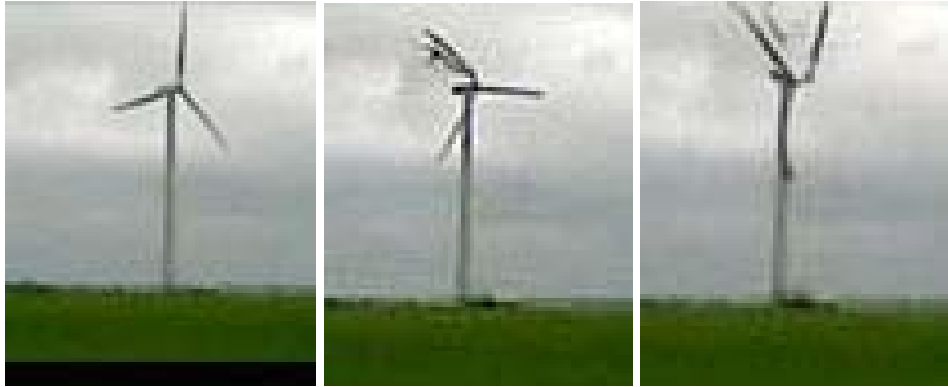
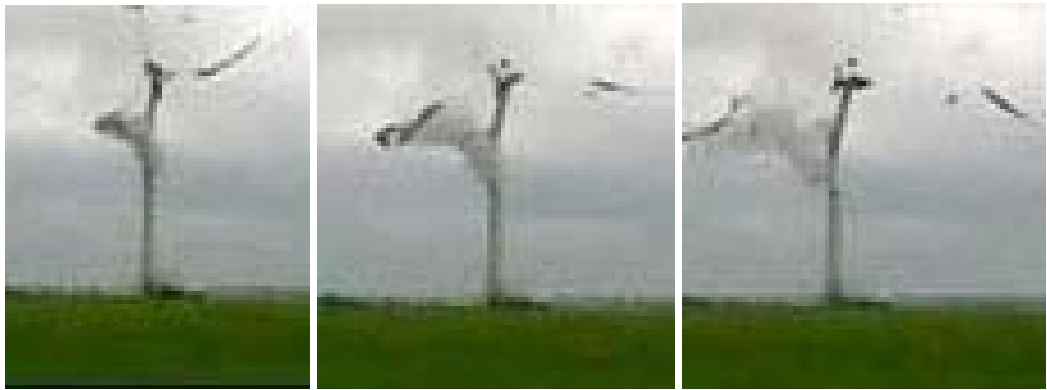
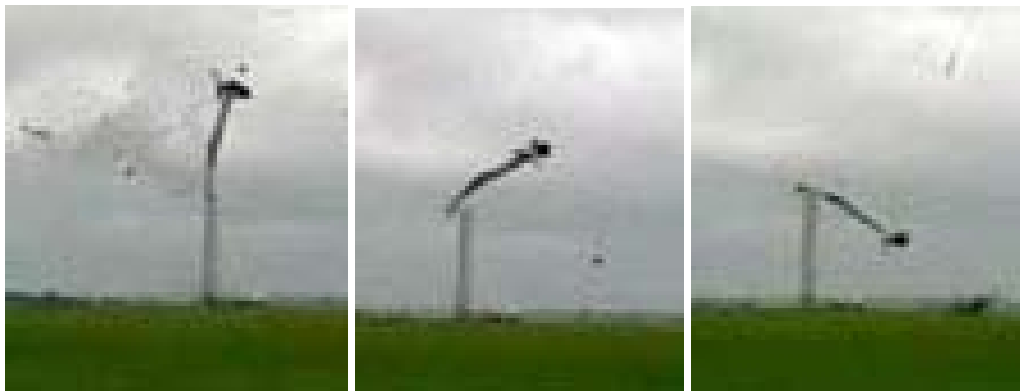
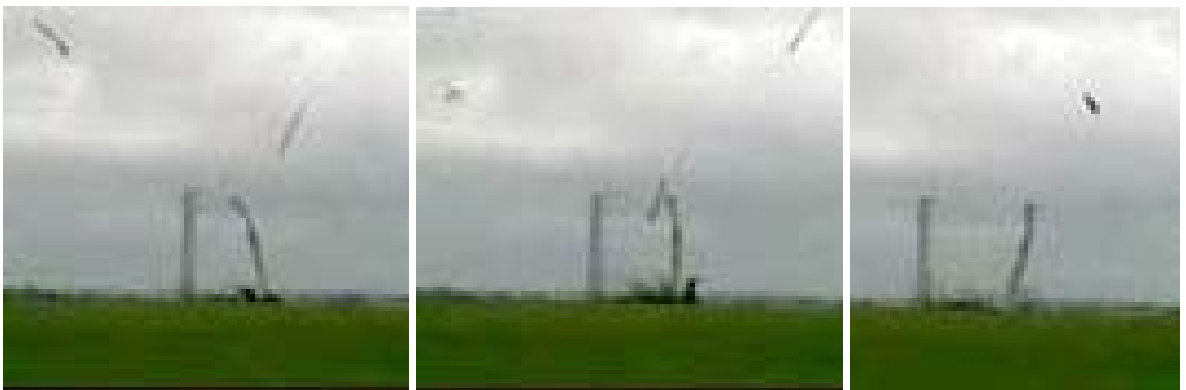
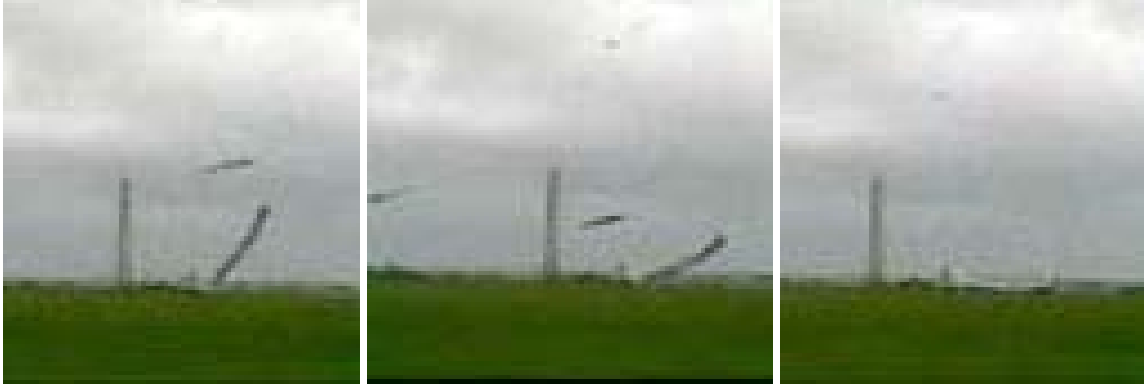
Figure 11. Runaway turbine disintegration clip sequence from video caused by failure of brake system, 2008. Notice how an initiating event of a single blade failure evolved into a failure sequence where the unbalanced nacelle and hub caused another failed blade to hit the structural tower, slicing it and causing it to collapse while the disintegrated rotor blades were ejected away. Source: UTube.

To prevent such an accident sequence an overspeed protection system is essential. Safety regulations specify that such a system must have two independent fail-safe brake mechanisms to stop the turbine.

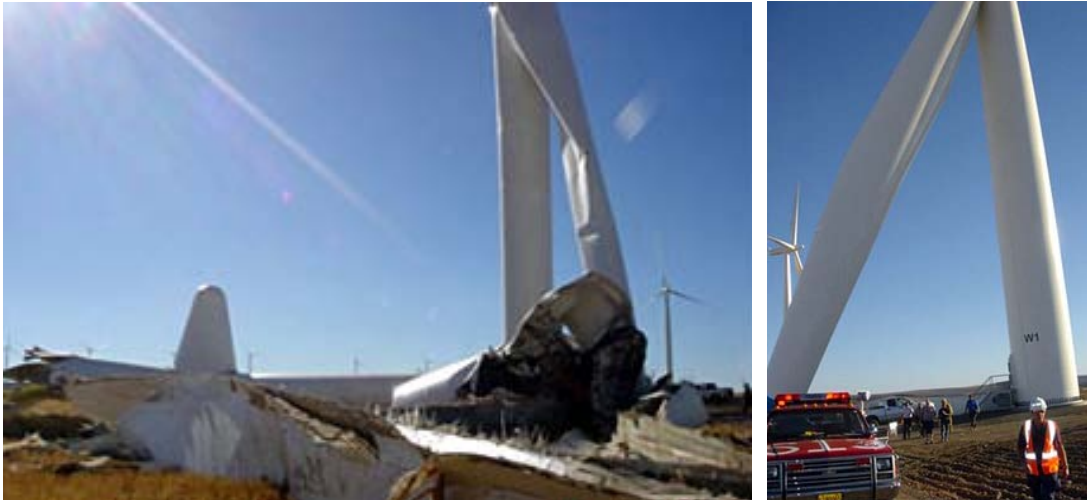
Figure 14. Tower collapse of a wind turbine. Wasco, Oregon, August 27, 2007.

A tower collapse in Eastern Oregon caused a person to fall to his death and another to be injured in August of 2007. The worker killed in the incident was at the top of a turbine tower when the turbine tower buckled about halfway up and toppled over. The injured person was inside of the tower at the time while the third worker, who escaped injury, was at the base. The turbine had been in operation for 500 hours and the workers were doing a routine inspection. The turbine was part of the Klondike III wind project, located near Wasco which generates 221 MW of electricity. It was using a mix of 44 Siemens 2.3 MW wind turbines and 80 General Electric 1.5 MW wind turbines.

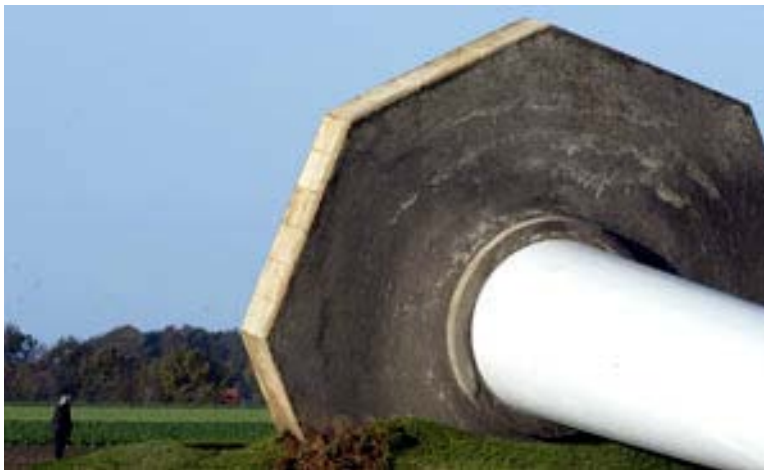
Figure 15. A 70-meter or 230-foot high tower collapsed in inclement weather at Goldenstedt, Germany, on October 28, 2002.

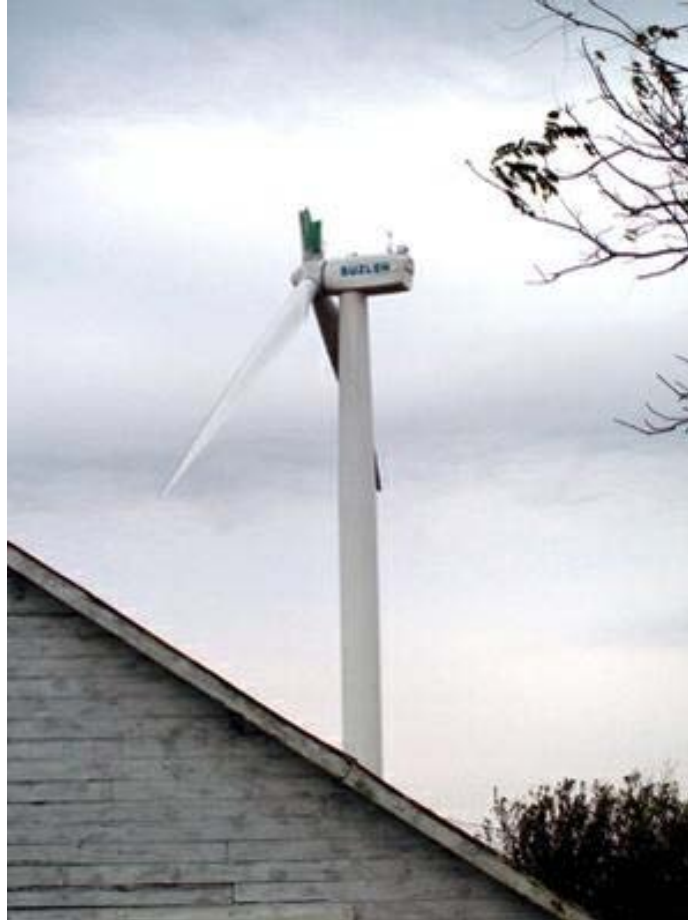
Figure 16. Blade failure at the stem on a 140 feet radius wind turbine at Wyanet, Bureau County, Illinois, October 22, 2008. The blade landed 150 feet from the base of the structural tower.

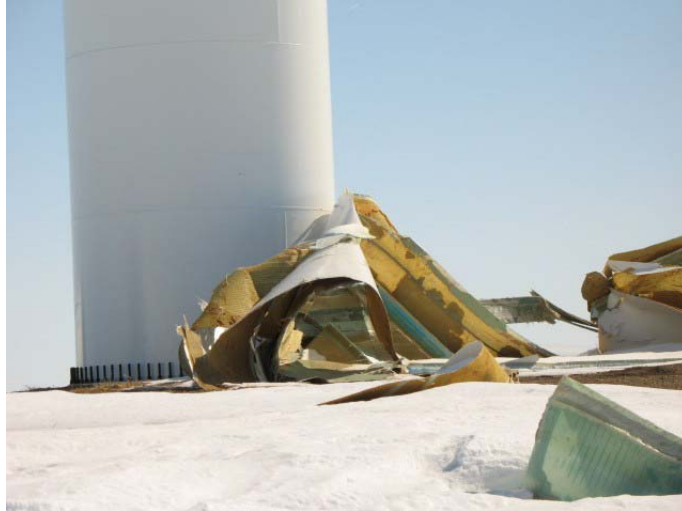
Figure 17. Turbine failure at Lake Wison, Minnesota, November 2007.

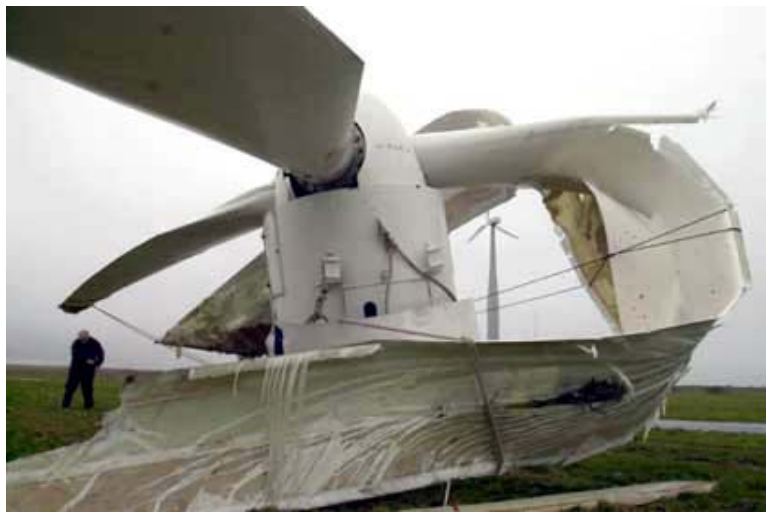
Figure 18. Structural collapse of a wind turbine in a 2002 storm. Source: Der Spiegel, DPA.

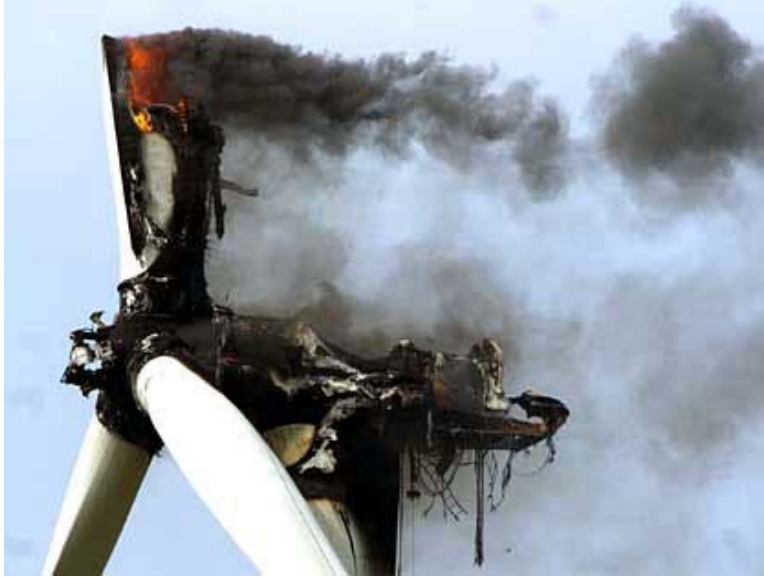
Short circuits, overheated alternators or gearboxes oil have caused fires.

Figure 19. Fire caused by a short circuit, frictional overheating or lightning in 2004 in Germany. Source: Der Spiegel, DPA.

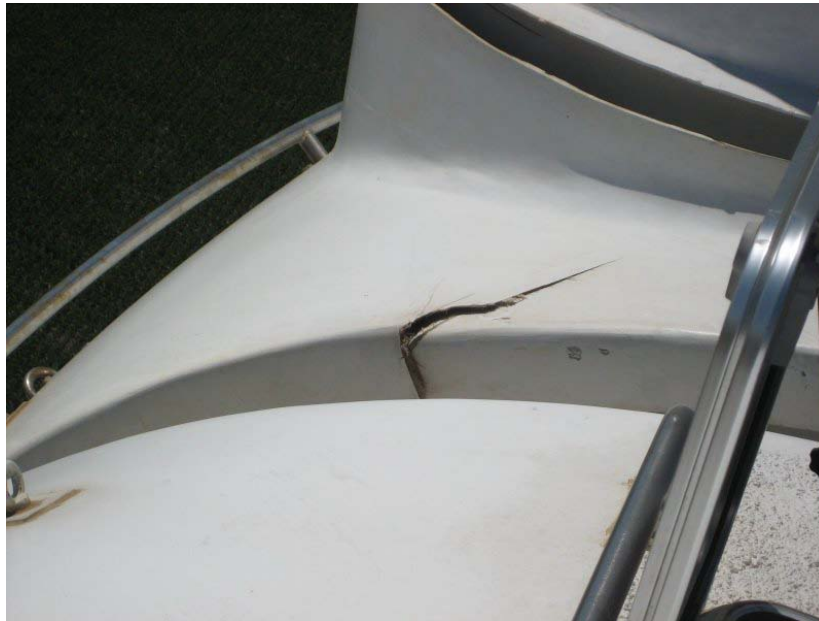
Figure 20. Structural crack near the hub of a wind turbine.

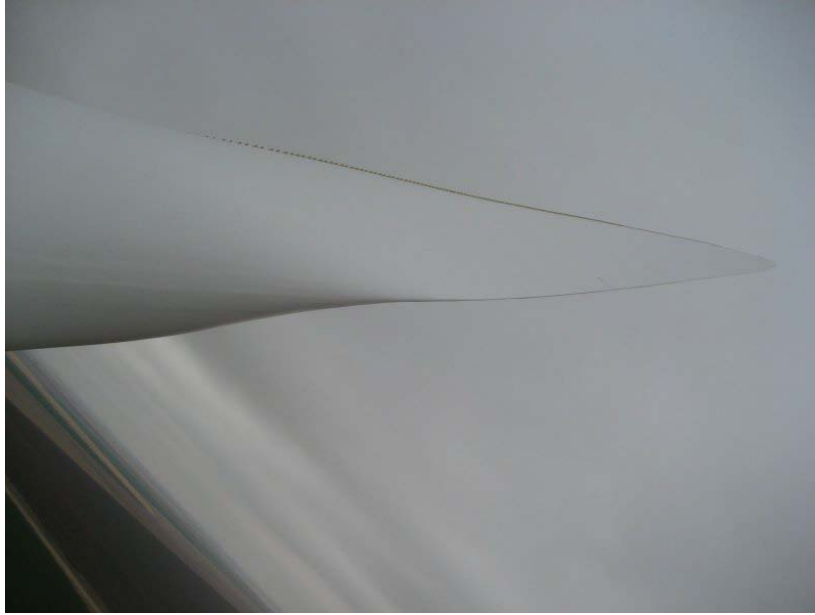
Figure 21. Structural crack caused by manufacturing defect in a rotor blade.

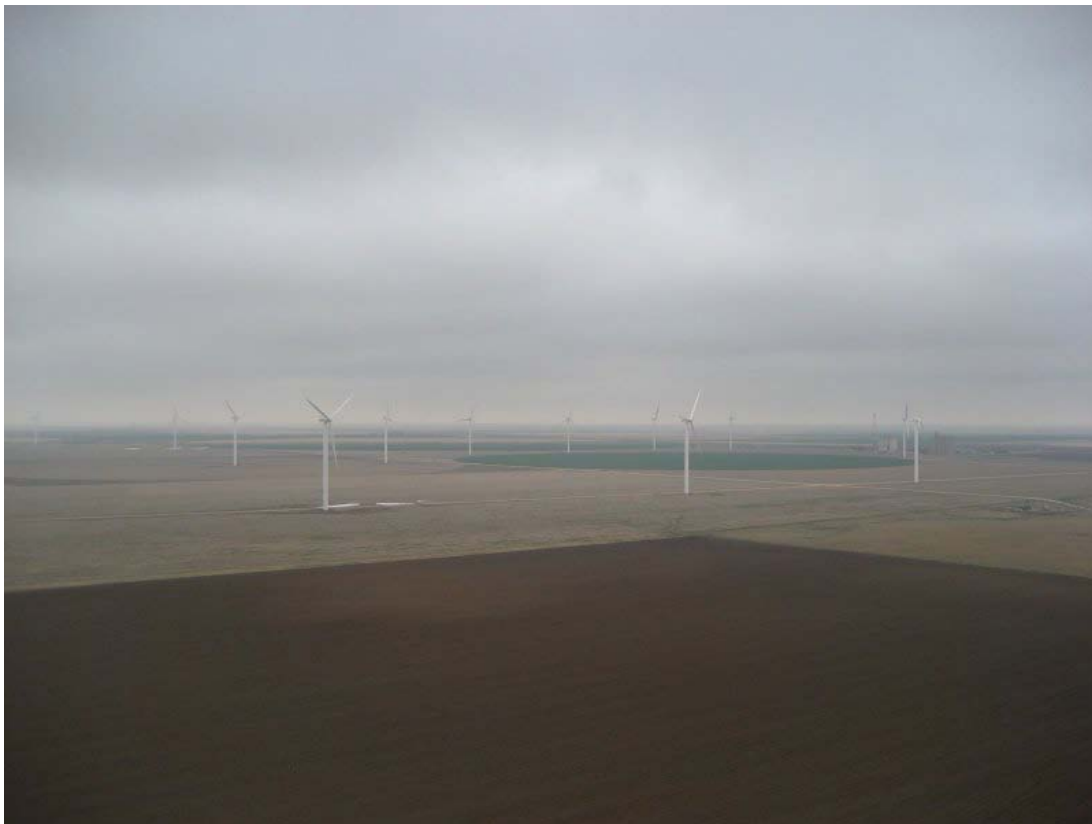
Figure 22. Recall and replacement of rotor blades in a wind farm due to a manufacturing defect, USA.

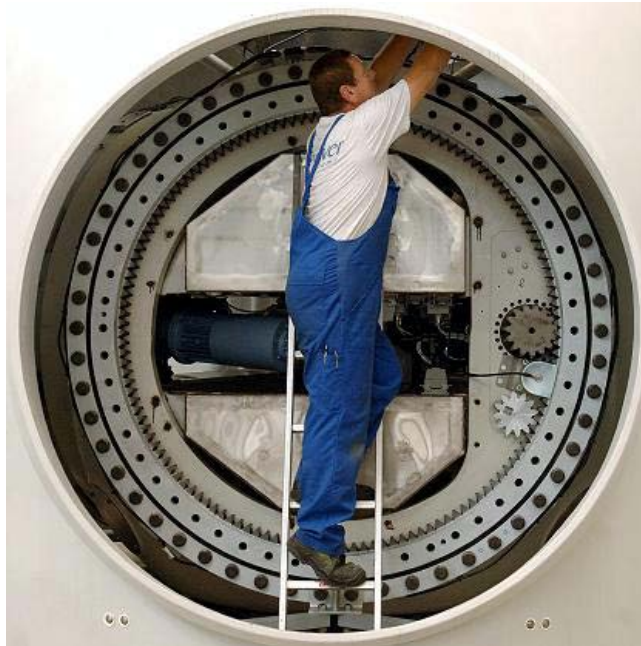
Figure 23. The gear boxes of wind turbines need replacement every five years, as they are the component that is most prone to failure from wind gusts causing misalignment of the drive train. Source: Der Spiegel, DPA.

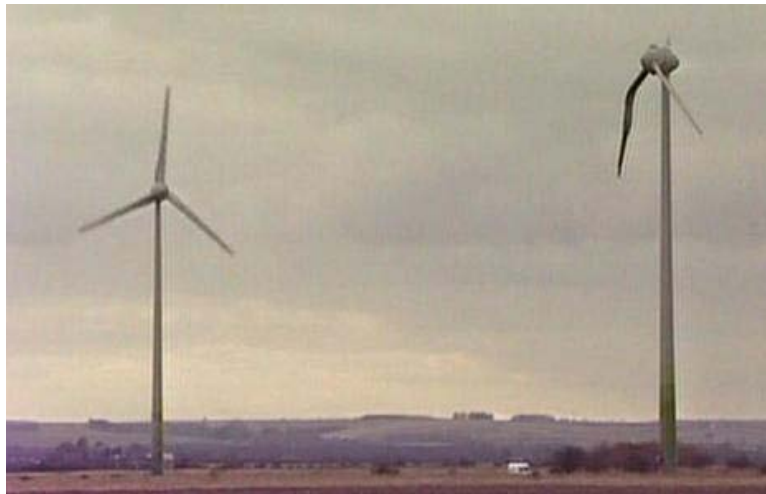
Figure 27. Blade failure due to possible ice shedding from one blade unto another or a manufacturing defect, Conisholme, Lincolnshire, UK.

Refusing to recognize ice shedding or structural manufacturing defects as causes of failure, UFO enthusiasts had their fun claiming that the damage to a Lincolnshire wind farm turbine was caused by a mystery aircraft. The turbine at Conisholme lost one 66 ft

If the turbine blade were still, it would take the equivalent of a 10 tonne load to cause such damage, but if it were rotating, or hit by a moving object, the force could be significantly less. It definitely was not a bird hit, but it could be ice thrown from a neighboring rotor blade that struck it. Most turbines have an anti icing system on the blades and maybe it failed to prevent the ice build-up."
